The Village Hall Schedule of Condition

Appendix A

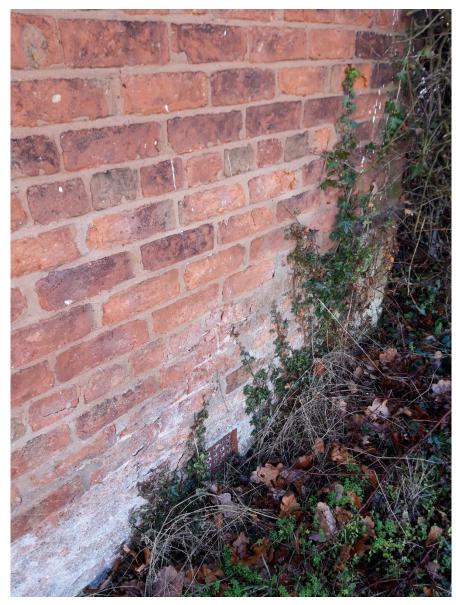
Vegetation growth to left elevation

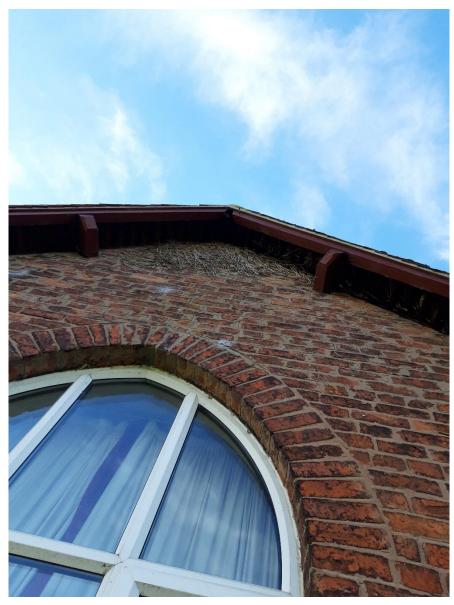
Previous creeper to left elevation

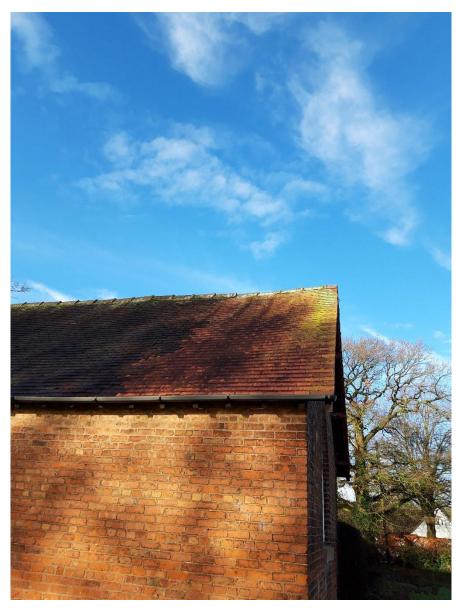
Dip in ridge

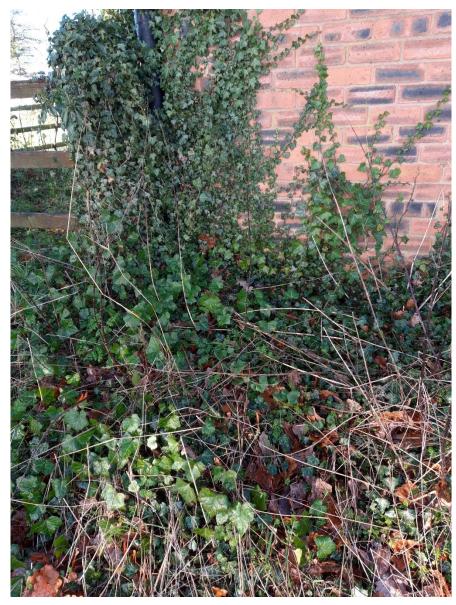
Vegetation growth to rear elevation

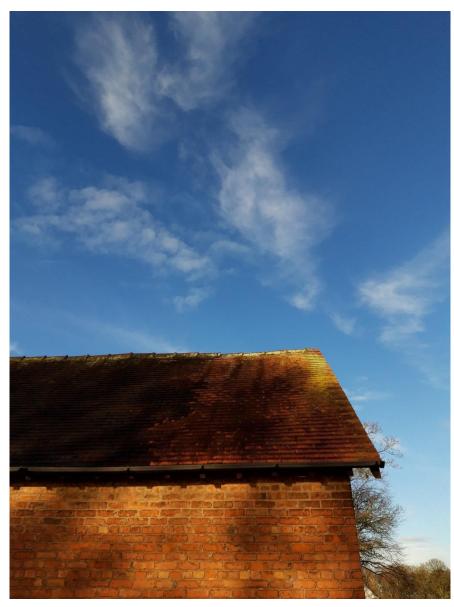
Dip in ridge

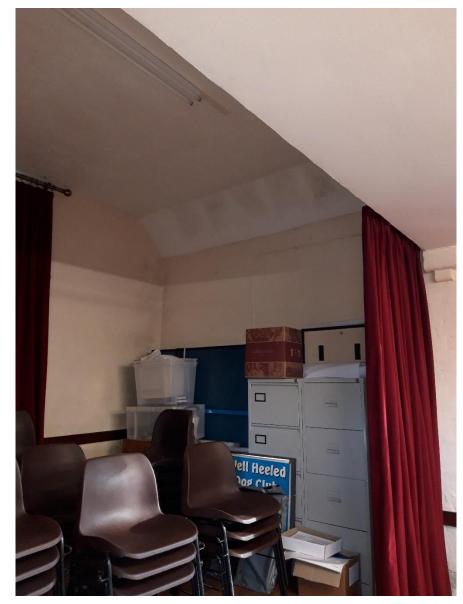
Condensation to walls

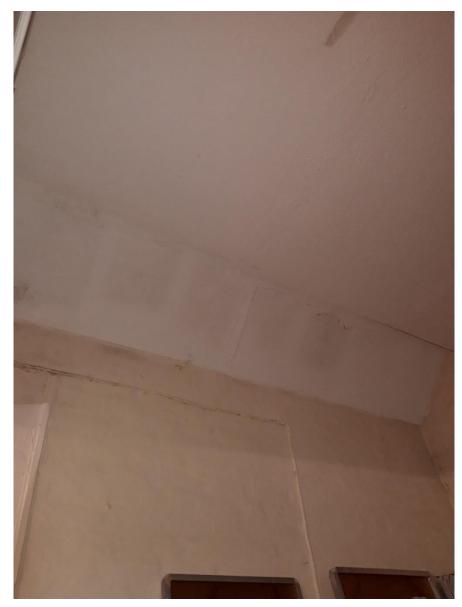
Condensation to walls

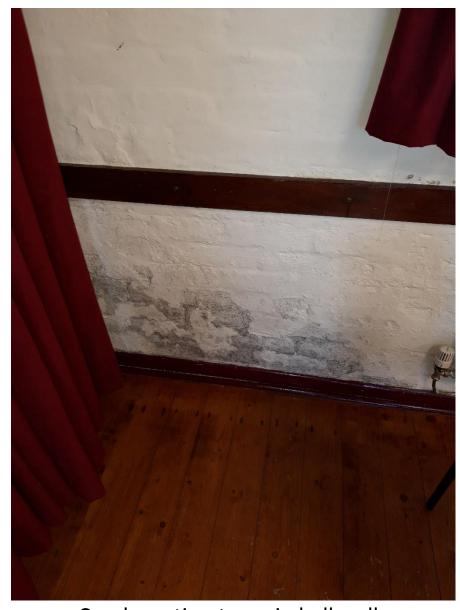
Condensation to main hall walls

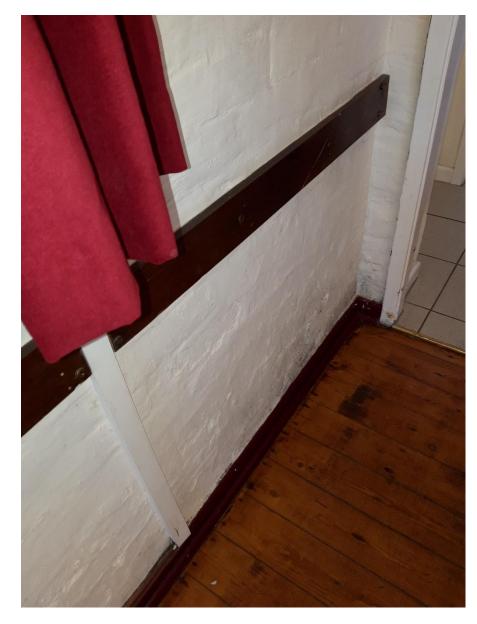
Condensation to main hall walls

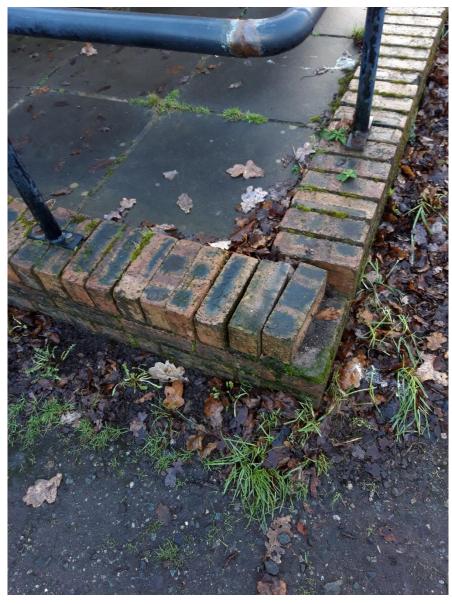
Damaged brickwork to access ramp

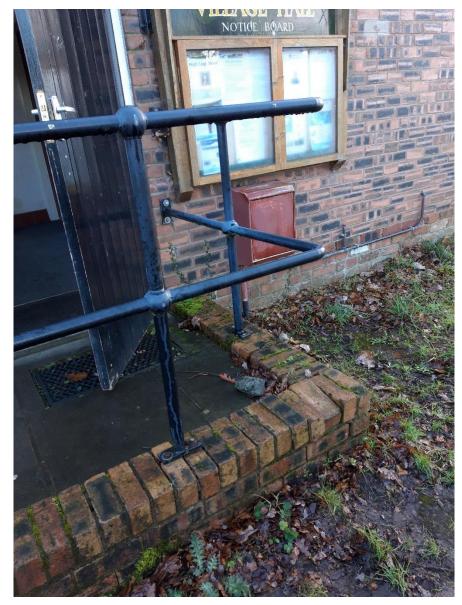
Damaged brickwork to access ramp
